**Bill Mills, Pontshill,  
Ross-on-Wye, Herefordshire**

**Building Recording**

Site Code BMR 05/101

**November 2005**

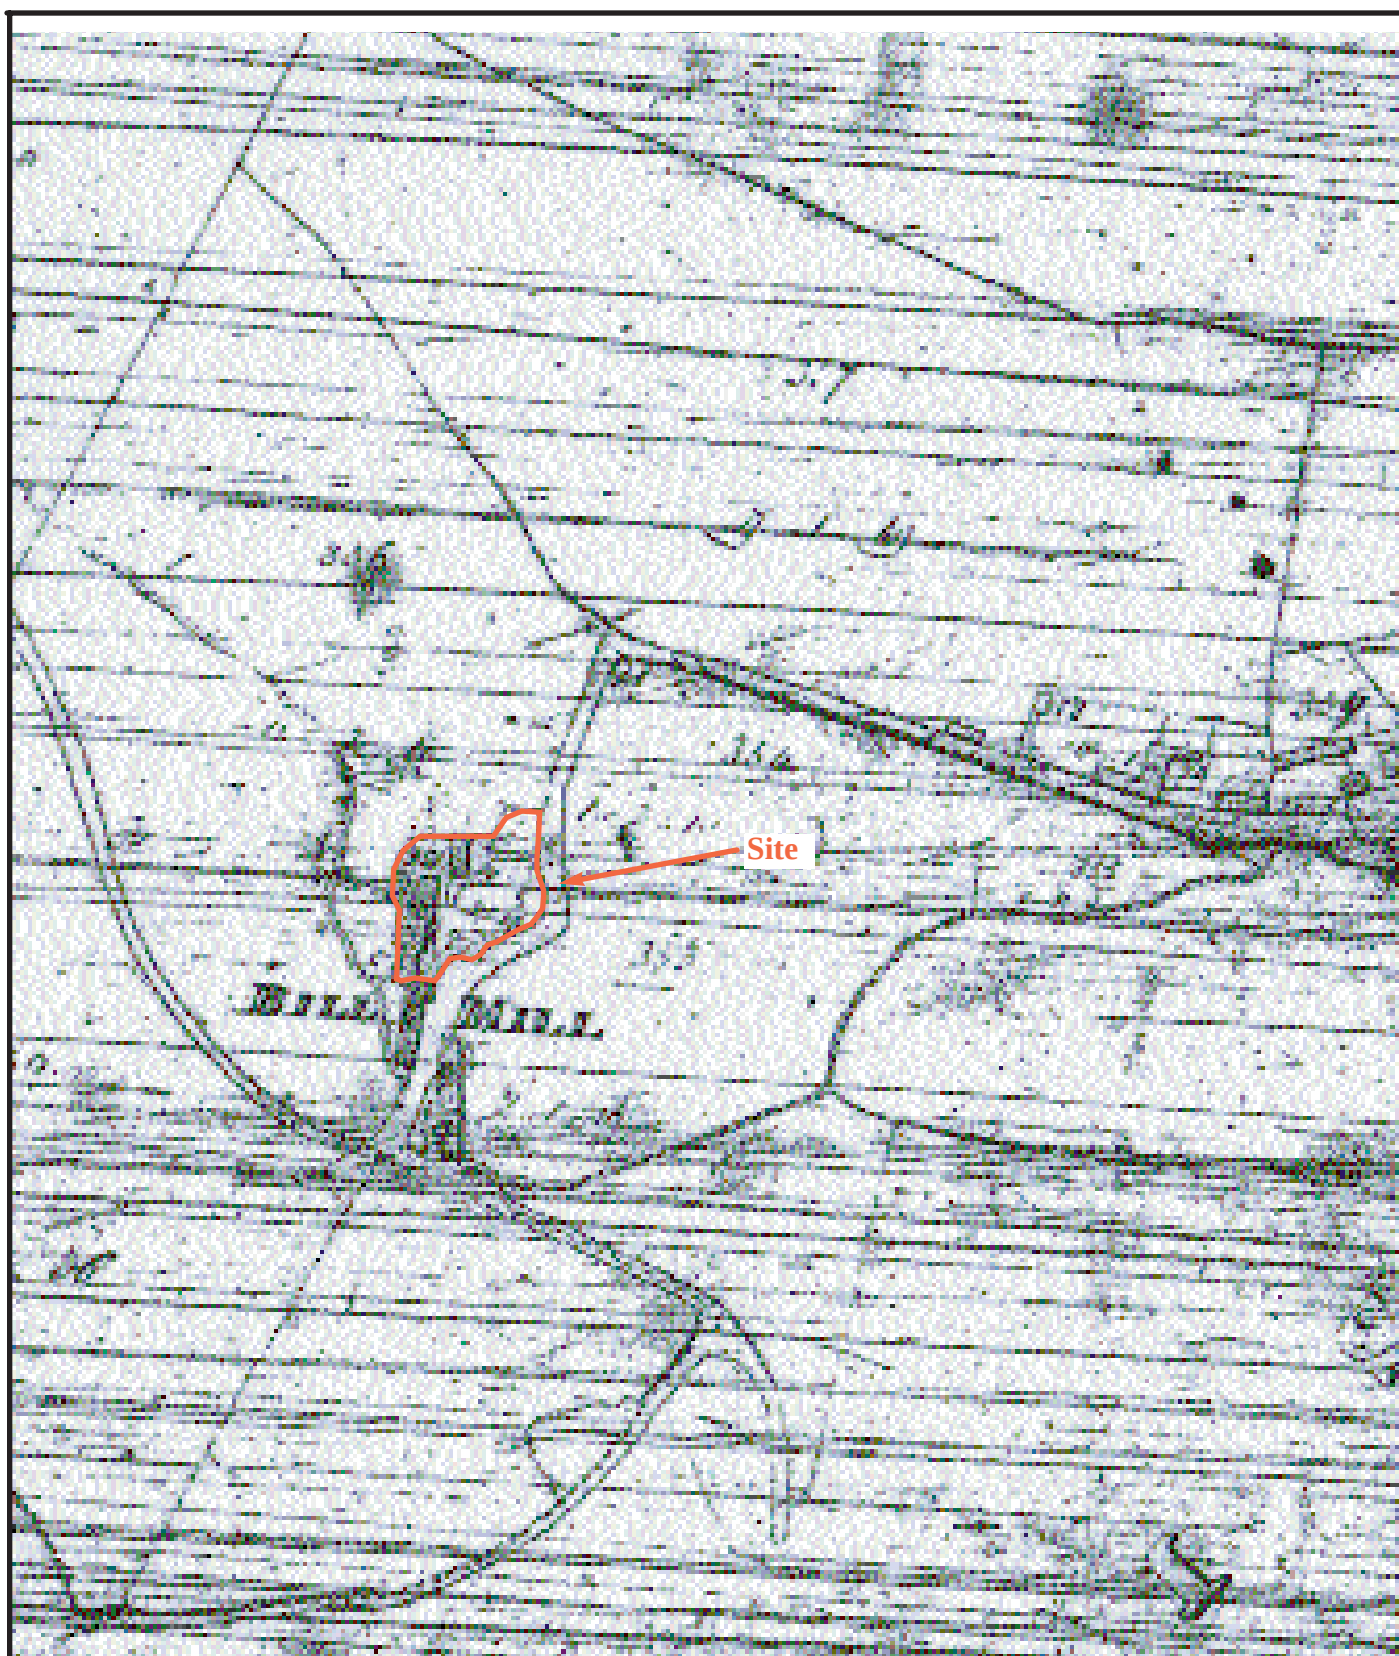
Figure 3. Plan of the watercourse, c.1820

Phase 2 covers the period between the construction of the timber-framed building (building 1 in the early 18<sup>th</sup> century), and the date of the first detailed plan of Bill Mills (produced specifically to show alterations to the water courses) of c.1820. Within this period, a lot of construction work and expansion had taken place, and the site had developed the core of the present day layout. This plan is reproduced as Fig 3, and shows the buildings on the site that at the time was operating as a paper mill.

In summary a property has existed on the site at Bill Mills since and probably prior to the 1700's that is the approximate date of construction of the timber-framed building. By the 1820's buildings 2, 3 and 4 had been added to the site and are clearly marked on the plan of the water courses at Bill Mills (Fig. 3). With the expansion of the business in 1891 further buildings were required to house the new machinery and manufacturing processes necessary for the bottling of beer and of mineral water. This also necessitated internal alterations to buildings 2, 3 and 4 especially with the introduction of a steam engine on site. Further expansion

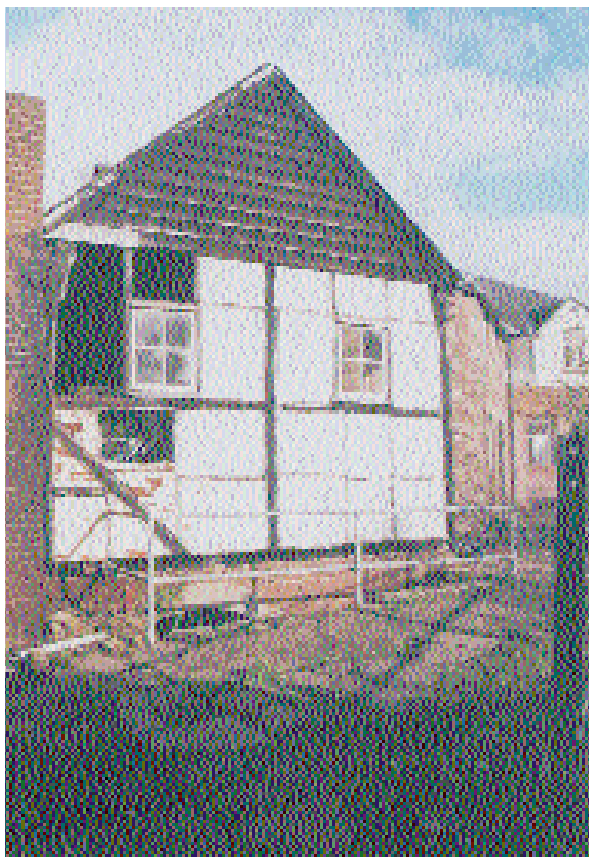
Building 1 (plate 1) is a three-bay timber-framed structure with box-framed walls and a king-post roof with treenched purlins. The main framing posts are jowled with six of the original eight surviving. The box frame has been infilled with hand-made red brickwork.

Plate 1. Building 1, southern elevation, Looking NE.

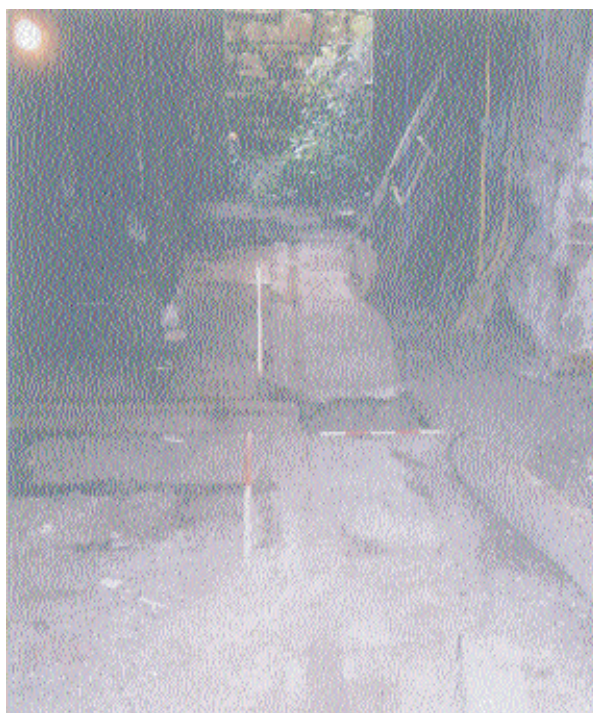
The basement has a large four-centred arched stone door opening at the western side of the southern elevation, and access to this is now down a set of stone steps. On the northern elevation there is an iron-barred window opening, now partially blocked with timber, brick and concrete, with a sandstone jamb and part of the sandstone sill surviving. The floor is of sandstone flags and drainage grooves in the slabs lead to a floor drain (plate 2). This building appears to have been constructed before the changes in ground level associated with the construction of the mill pond. The door and window opening described above, currently below ground level, were presumably originally at ground floor level.

Plate 2. Building 1 basement, looking south towards the door, showing drainage channels and drain in the flag floor 1m, 2m and 0.50m scales.

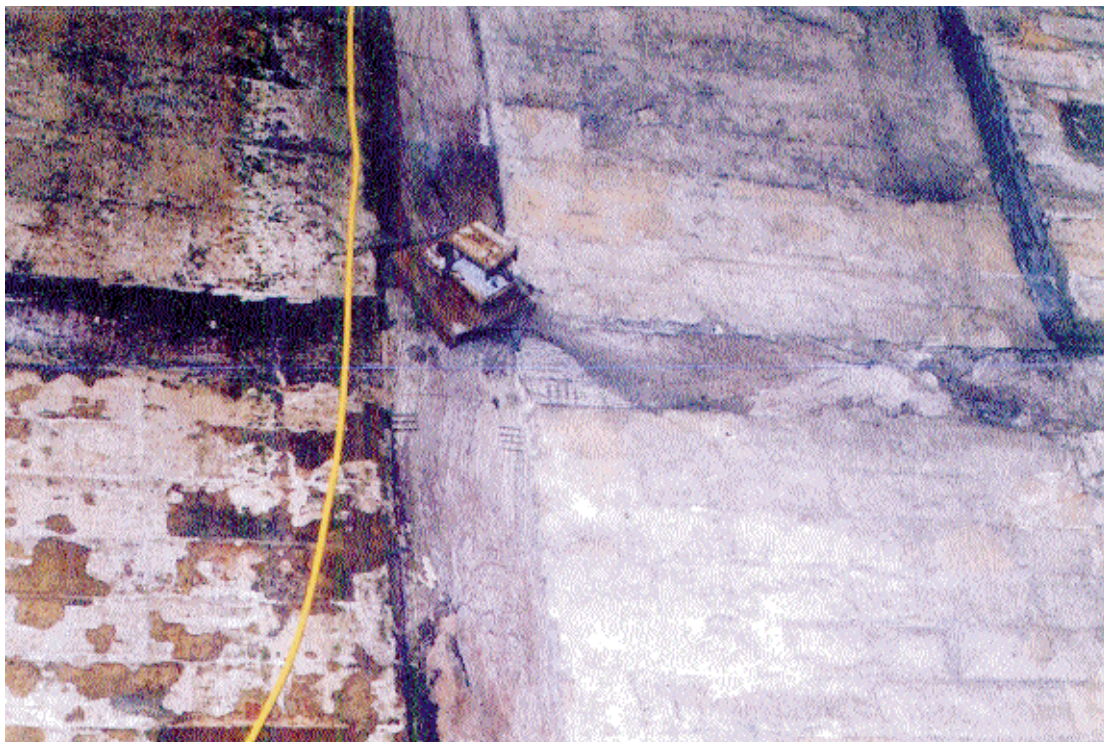
Weather boarding has been added to the external faces of the north and south elevations. On the external face of the western elevation the original carpenters' marks were recorded (plate 4).

Plate 4. Building 1 Carpenters marks III and IIII, External west wall, Looking E.

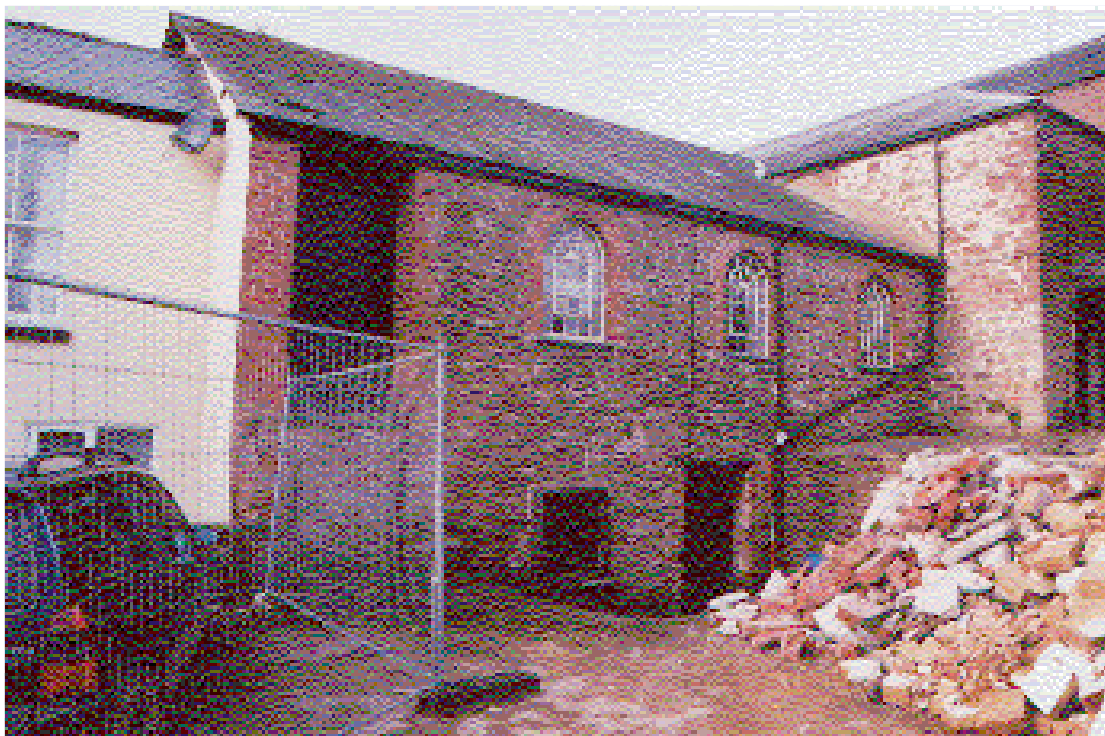
This building (plate 5) was located at the eastern end of the complex. It was built of coursed red sandstone blocks and has a slate roof. It is a simple rectangular two-storey building with a basement and ground floor level (originally at ground and first floor level, prior to the landscaping associated with the creation of the mill pond).

Plate 5. Building 2, Looking NW, Scales: 2m.

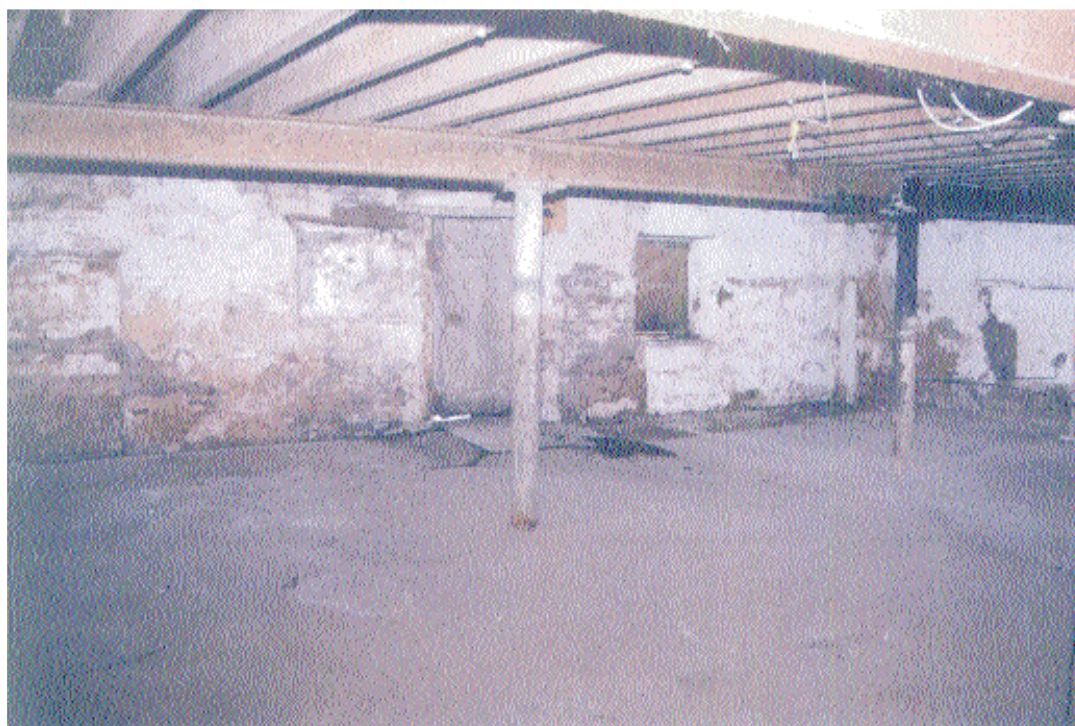
Plate 6. Building 2 Basement, eastern elevation, showing blocked doorway and window.

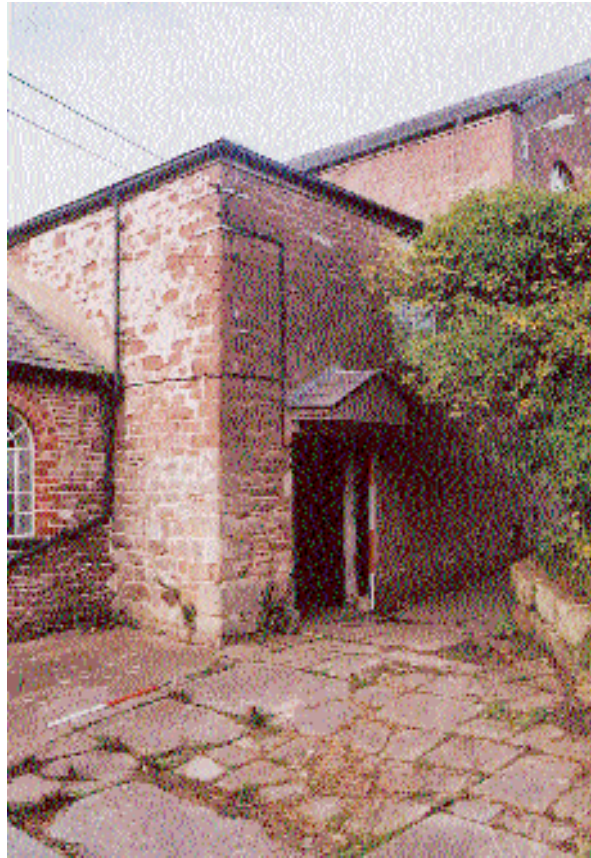
Building 3 is a large rectangular three-storey sandstone building to the north of building 2. The front (eastern) elevation stands proud of the line of building 2 (plate 7). At the ground floor level there is a simple door opening with a timber porch canopy over through the southern half of the wall and at the first floor level there are two plain two-light windows. The western external elevation has a rectangular four-light timber slatted window at basement level, a similar window on the ground floor, and a smaller version at first floor level (plate 8).

Plate 7. Building 3, Front eastern elevation, scales: 2m and 1m.

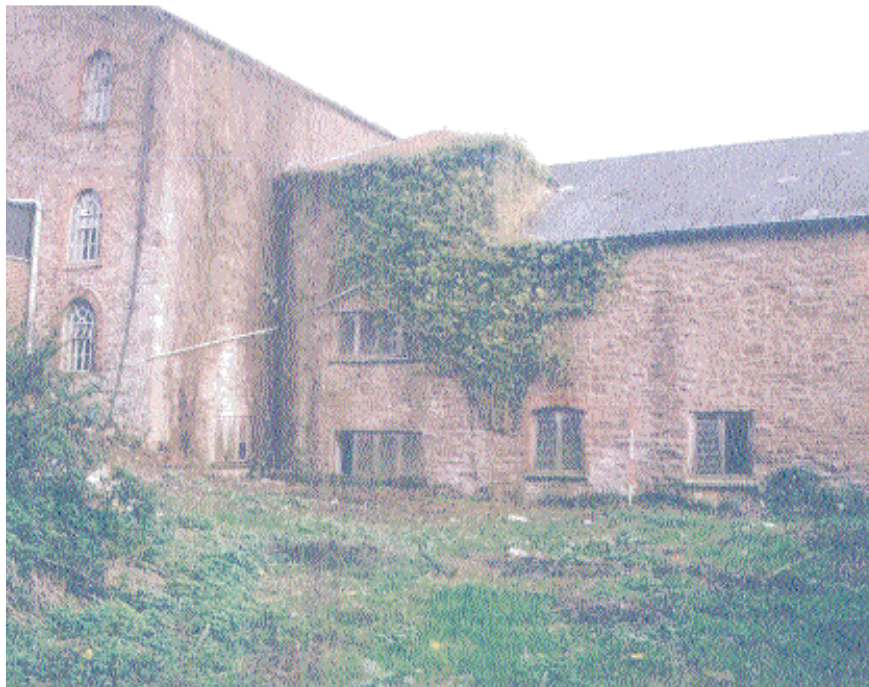
Alterations to the roof of building 2 to the south were recorded where the roof structure had been extended to the north to meet and tie in to the different roof alignment of the later building (the ridge of the roof of building 2 runs north-south, whereas building 3 runs east-west) (plate 8).

The ground level on the western side of the building is lower revealing the rectangular, timber-slatted, basement window at the western end of the southern elevation (plate 8). There are single metal-framed windows with round-headed brick openings on each of the ground, first and second floors to the southern side of the western elevation, although the bricks used are different on the ground floor window.

Plate 8. Rear western elevation of buildings 2, 3 and 4.

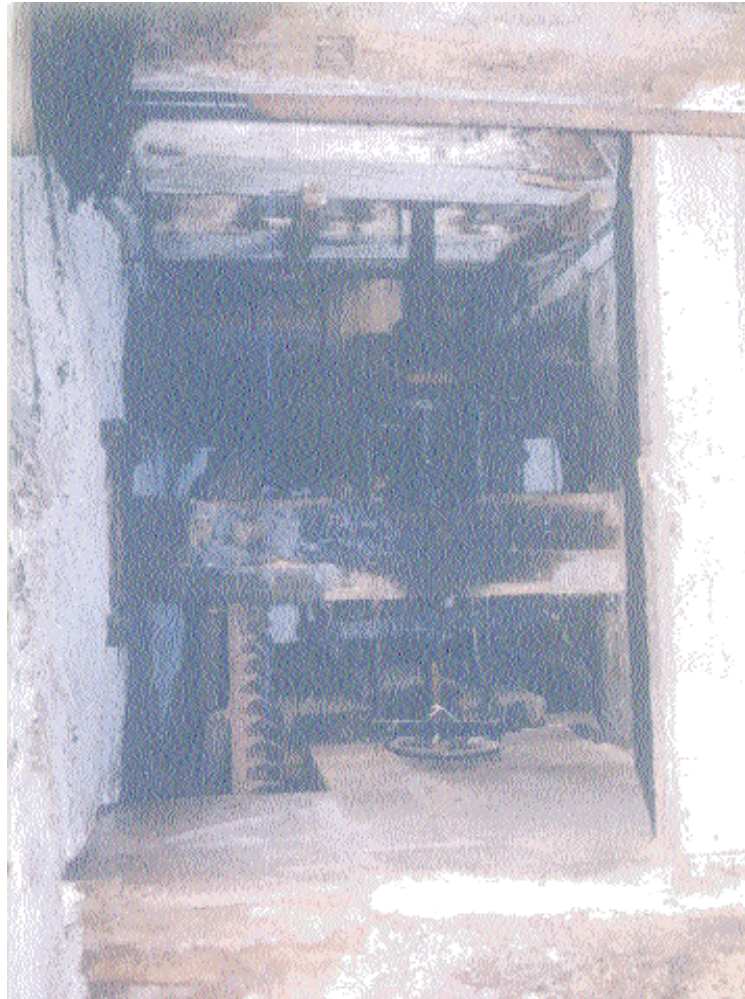
This building has the watermill wheel situated against the outer face of the northern wall with the wheel axle penetrating the wall. The pit wheel was observed emerging vertically above its stone housing on the axle shaft. This would have driven the horizontal wallower cog (Plate 9), and above this on the main shaft were the spur wheel and the stone nut, with the shaft then rising through into the floor above. Three meal spouts from the floor above are present in this room, two of which had grain sacks attached. A belt and pulley system is also present in this room.

Plate 9. Pit wheel and wallower, Building 3, Basement, Looking E.

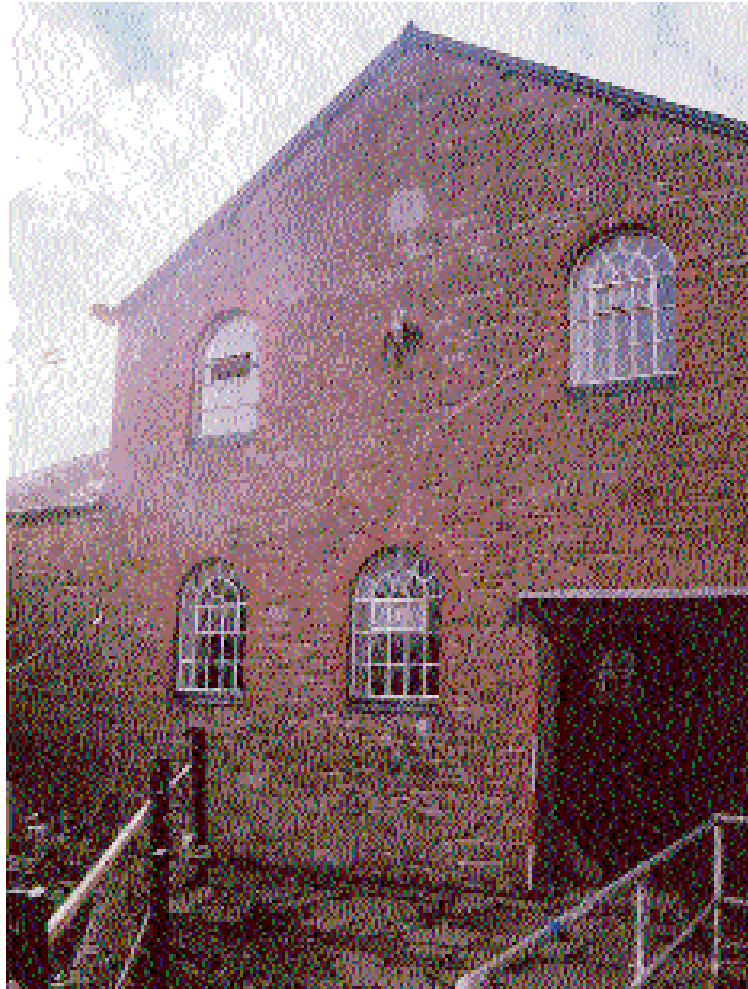
Building 4 (plate 13) is a rectangular 4-storeyed building situated to the north of building 3. It is built of red sandstone blocks of larger size than buildings 2 and 3 and with less regular coursing, and has a slate covered roof. On the front or eastern elevation of the building there is a door opening at the northern end of the wall at ground floor level. The current door sits in an opening with brick jambs and a stone segmental arched head. At first floor level there are two round-headed brick window openings with metal-framed windows. There are two identical windows at second floor level with a central circular opening with wall lamp. A date stamp (dated 1891) is located above this opening with the initials W&S for Wintle and Sons.

Plate 13. Building 4, Looking SW, Scales: 2m.

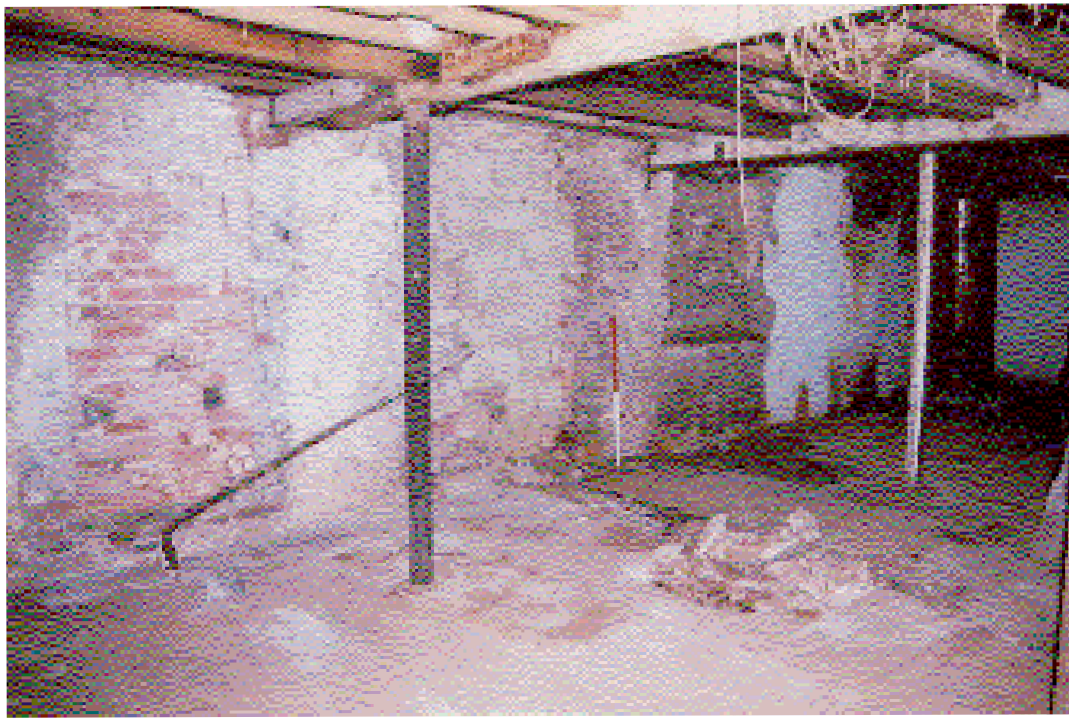
Plate 15. North Wall, Building 4, Basement, Looking NE, Scales: 1m.

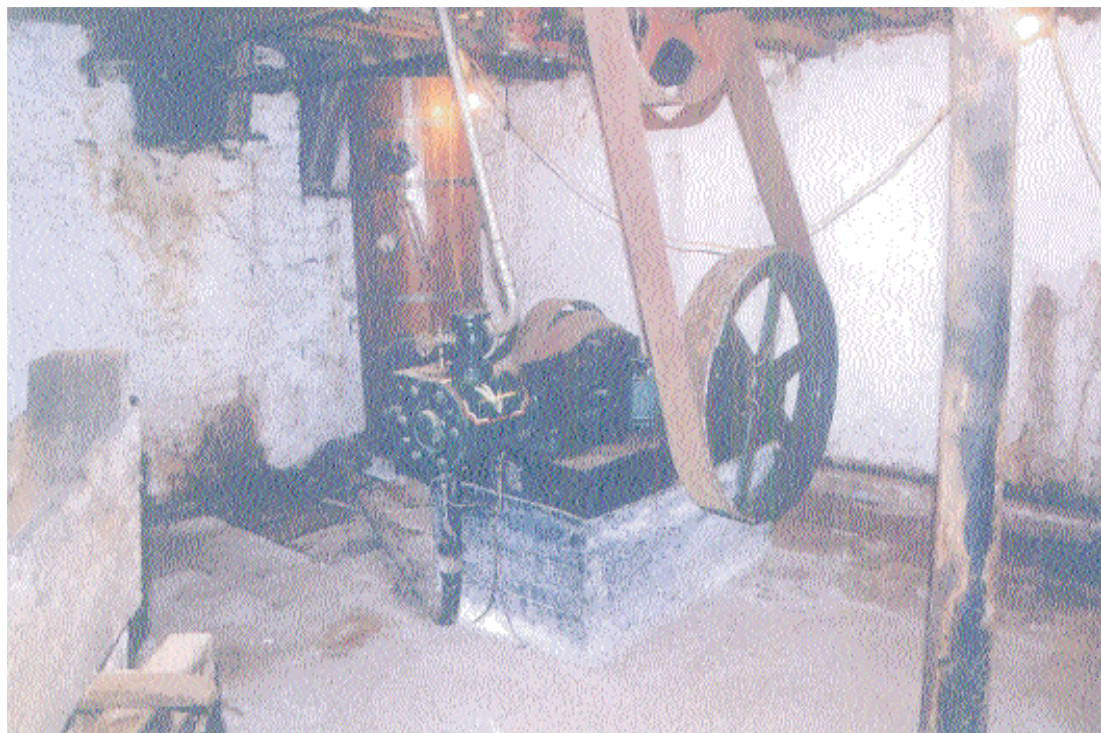
In 1899 a second steam engine was installed in the basement of building 4, and this is present today. It is unclear whether this Tangye engine was intended to replace the existing engine or to work in tandem providing more power for the ever expanding manufacturing process.

Plate 16. Tangye Steam engine and boiler, Building 4, Basement, Looking NE.

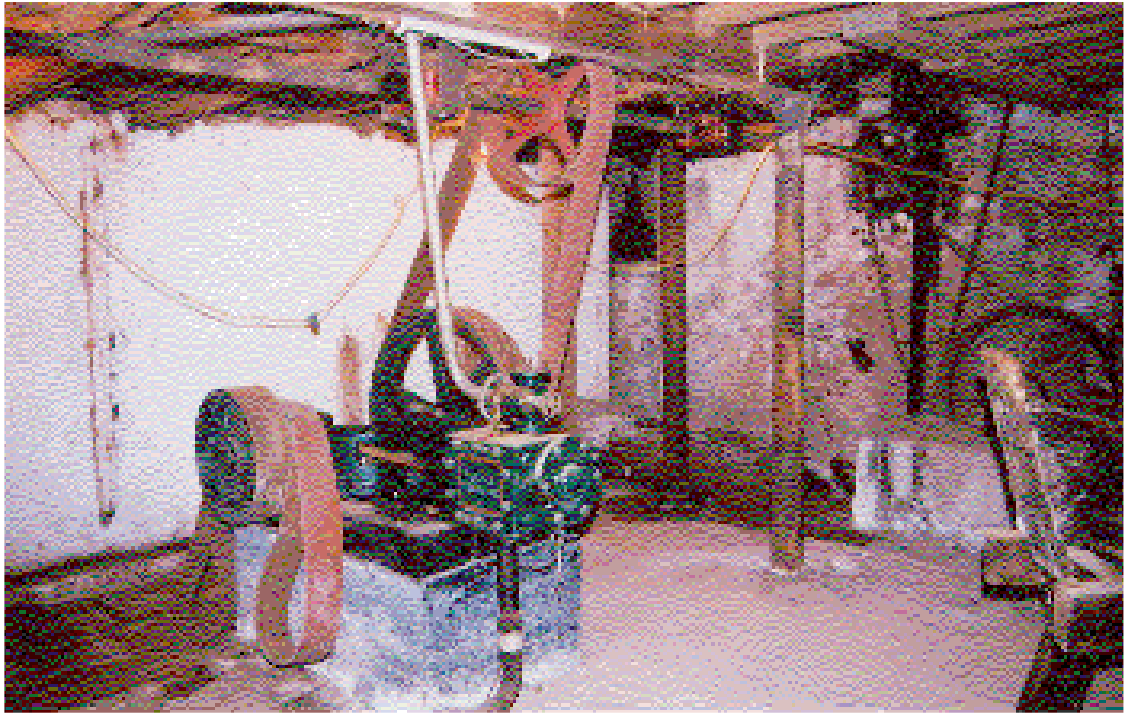
Plate 17. Tangye Steam engine and water wheel enclosed behind the wall, Building 4, Basement, Looking SE.

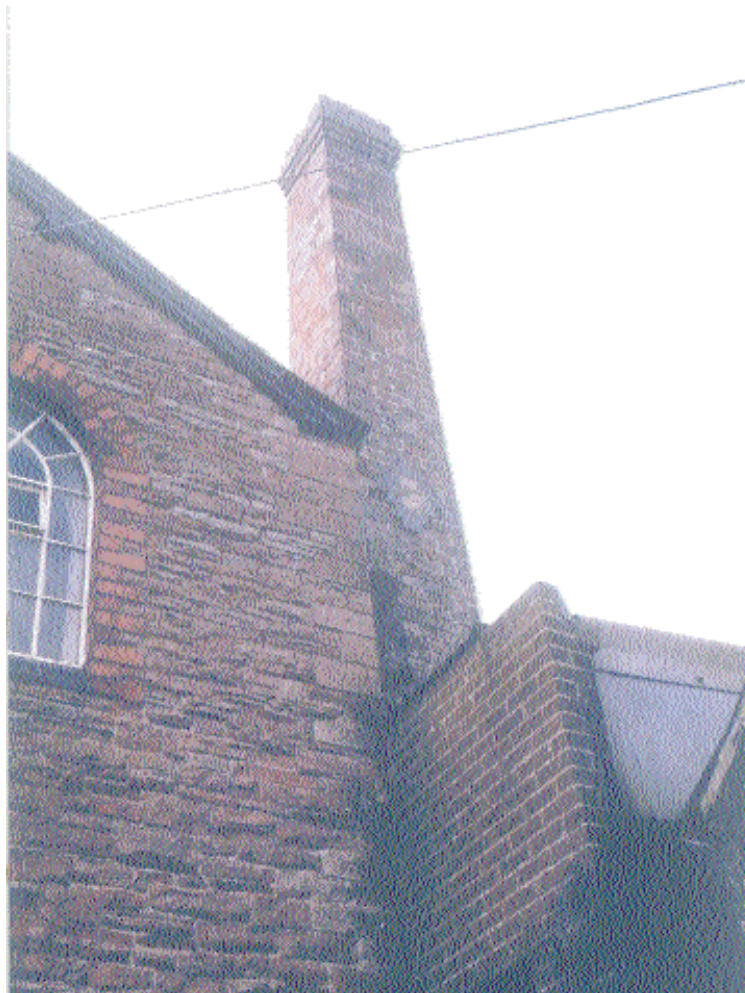
Plate 19. Chimney with lozenge design, Looking NW.

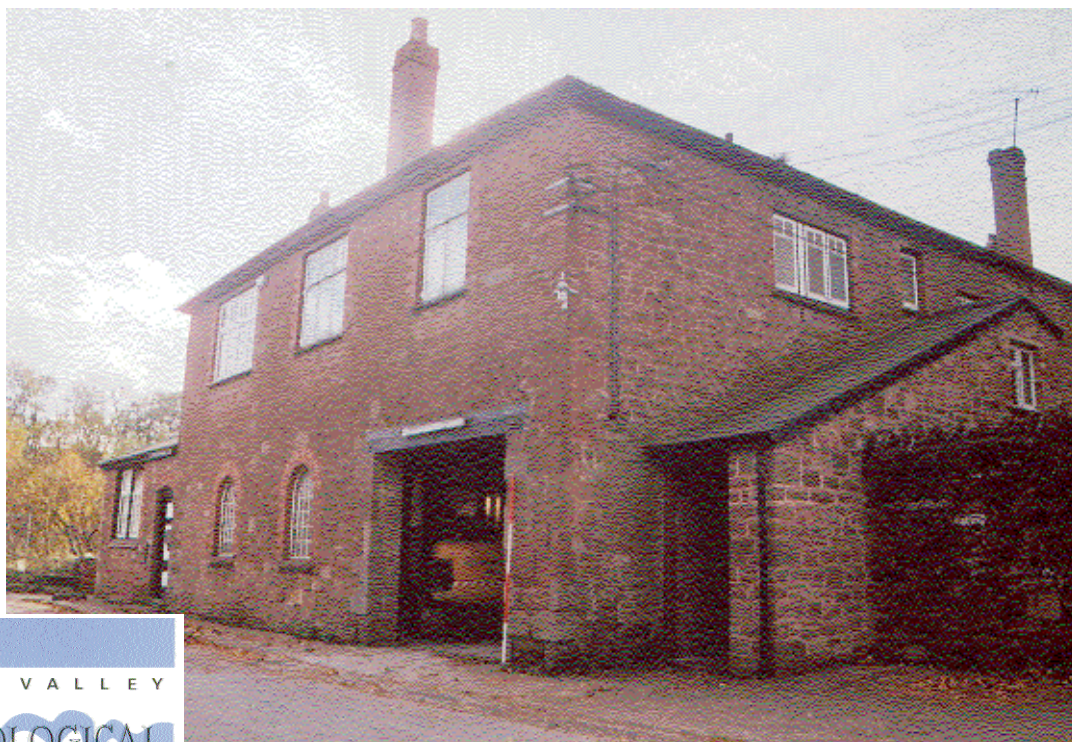
The last addition to this site not observed on the Ordnance Survey of 1992 is the external staircase on the north wall of building 7. The boxing for this structure is visible on the ground floor and the stonework is more modern in appearance than the remainder of the building. It was probably constructed to allow access to the first floor without entering the ground floor, possibly indicating it was a dwelling separate to the business below.

Plate 20. Building 7, 8 and external staircase, Looking SW,  
Scales: 2m.

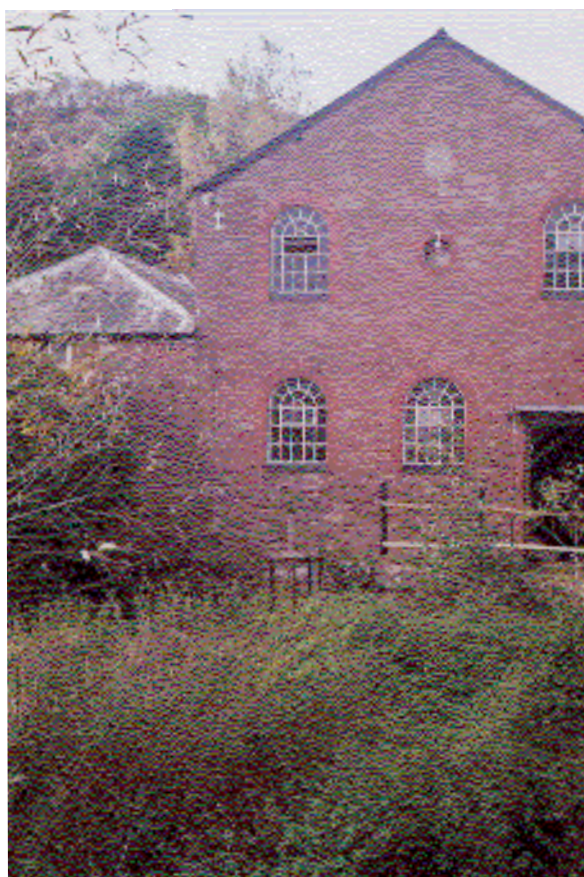
mill pond. Here the water is retained and a sluice gate at the western end of the pond used to control the flow of water entering the water wheel within the basement of building 4 (Plate 22). This enables a head of water to build which is more powerful entering the wheel and makes the mill more efficient. After passing through the wheel the channel of water could be observed passing under the stone slabs and perforated quarry tiles in the basement of building 3, fig. 14, flowing west as the tail race until it passes out underneath a stone arch and back to the Castle Brook.

Plate 22. Mill pond and sluice gate. The mill wheel is in the basement of building 4 immediately behind the sluice gate, Looking W.

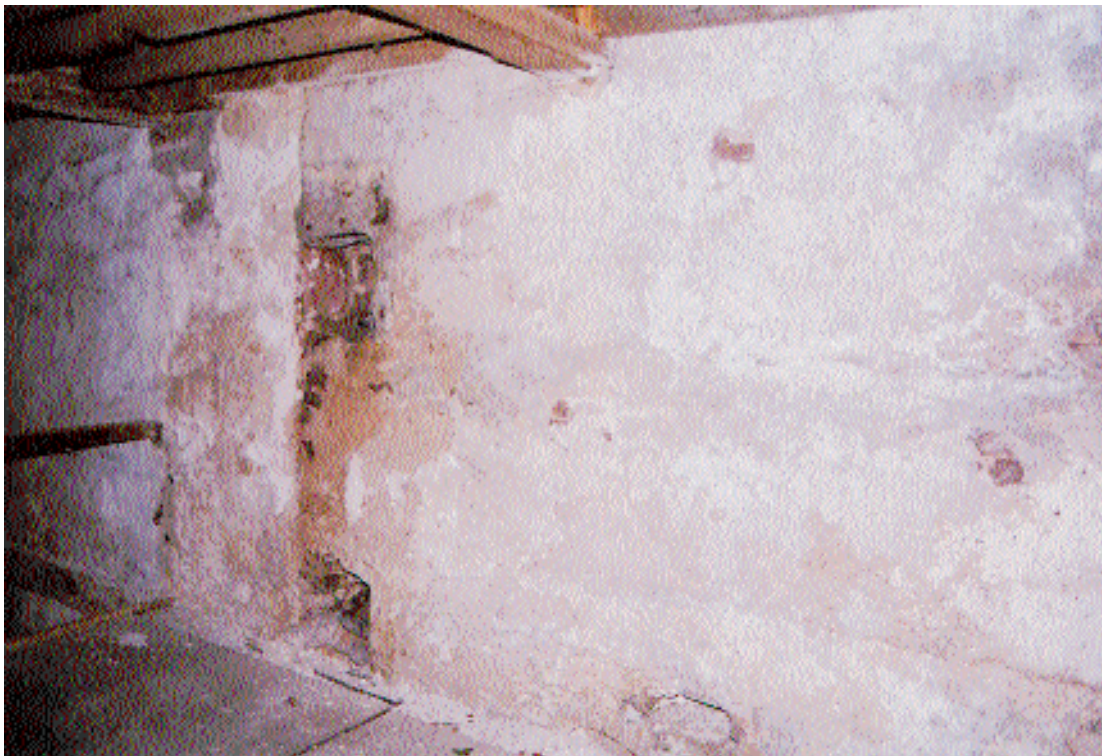
Plate 23. Quoin stones of Building 3 observed in south wall of Building 4, Building 4, Ground floor, Looking SE

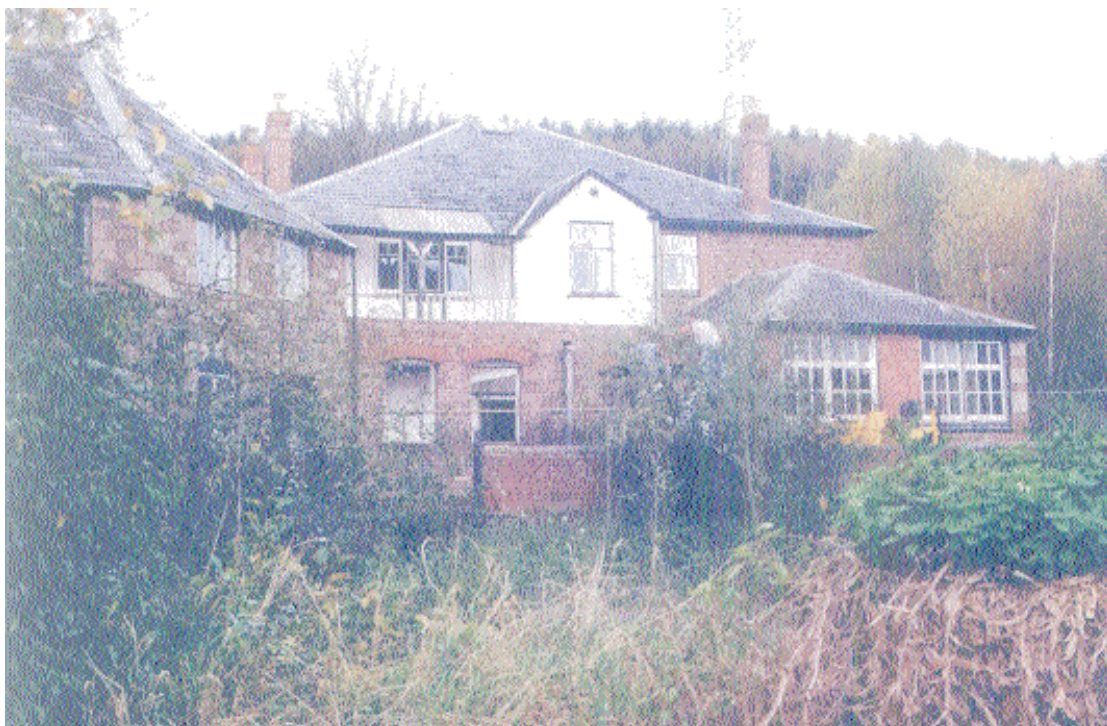
Plate 24. Mill pond and buildings 6, 7, 8, and 9 looking north.
